*Industrial Materials for the
Future R&D Strategies*

*A Case Study of Boiler Materials for
the Pulp and Paper Industry*

*David R. Howell, Richard Silbergliitt,
Douglas Norland*

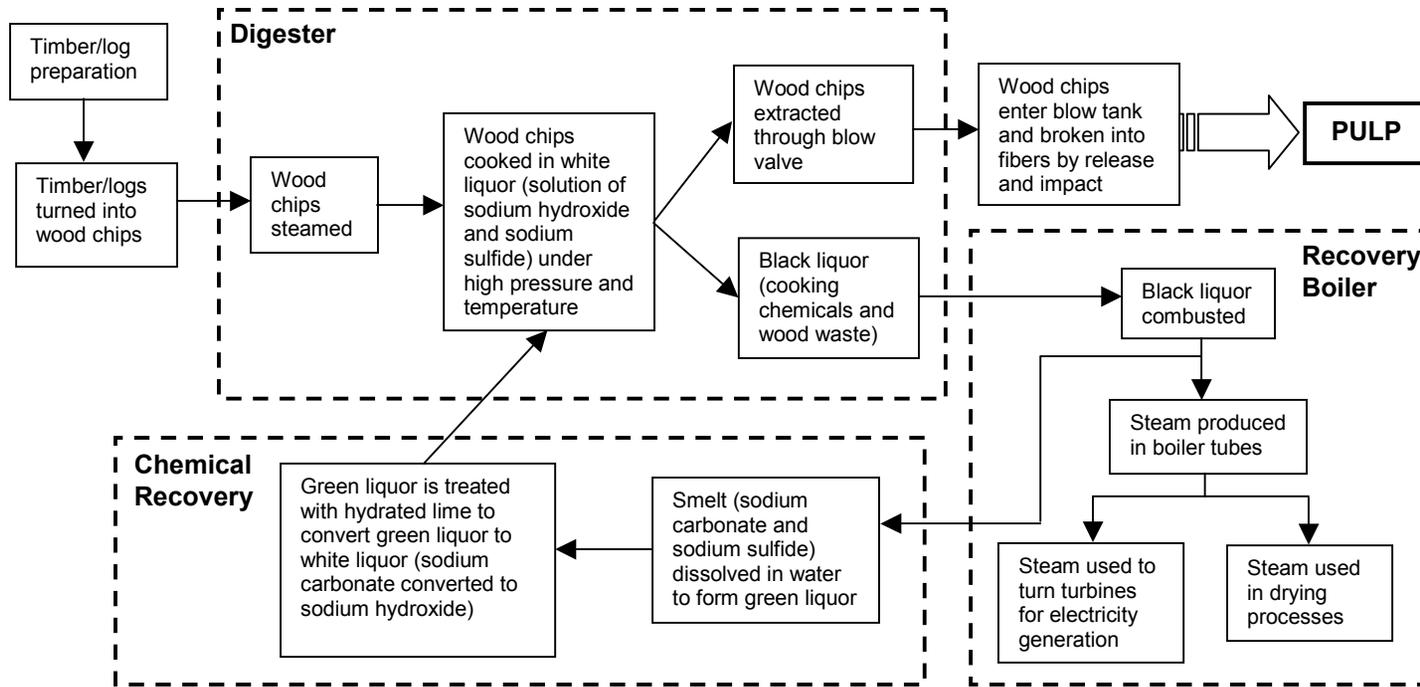
Figure 9: The Kraft Chemical Pulping Process

The wood chips that have been reduced to a manageable size are sent to the digester. The digester steams and cooks the wood chips in a solution of sodium hydroxide and sodium sulfide, known as white liquor, under high pressure and temperature. The wood chips are then broken into individual fibers by release and impact through a blow valve into the blow tank. These fibers are called the pulp and can be used for papermaking. The leftover substance composed of chemical materials and wood impurities (consisting of mostly lignin) is called black liquor.²⁵

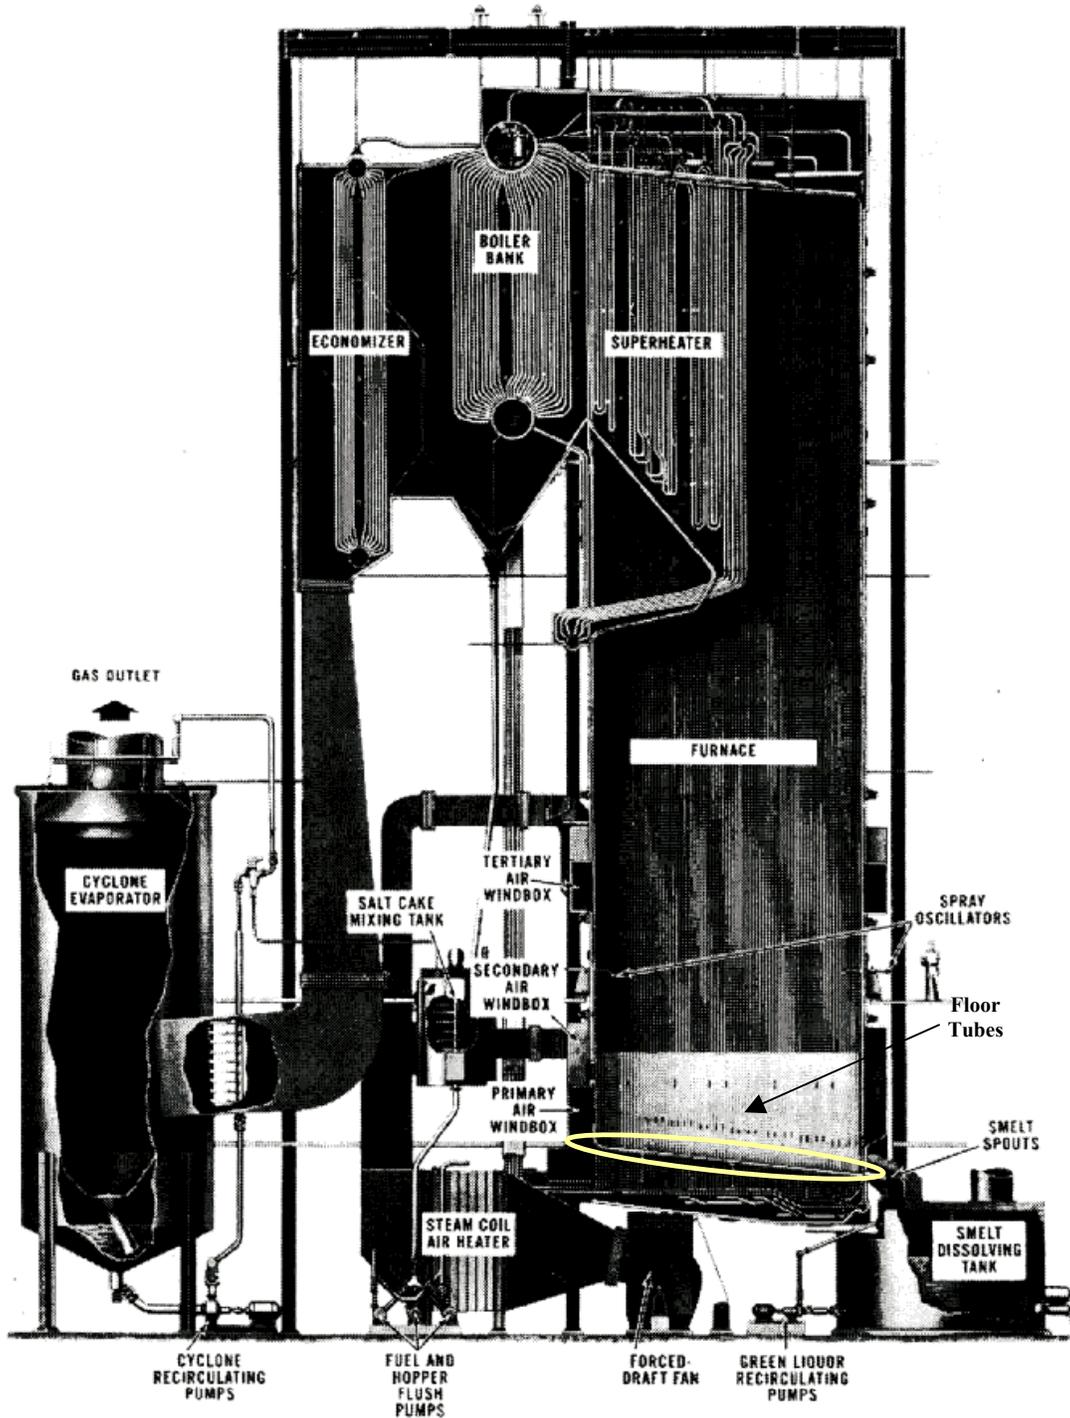
Figure 10: Babcock and Wilcox recovery furnace (circa 1968)³²

When the black liquor is burned, a substance composed of sodium carbonate and sodium sulfide – called smelt – forms at the bottom of the boiler. The salts that make up the smelt have a high melting point and thus form a solid at the surface of the water-cooled boiler tubes. Above the layer of solid smelt is a layer of molten smelt that reaches depths of several inches and temperatures of 925°C – 980°C (1700°F – 1800°F).²⁷ A critical task in the recovery boiler is to assure that the water flowing through the boiler tubes does not leak and subsequently come into contact with the molten smelt. If this happens, an explosion can occur in the boiler because of the instantaneous vaporization of the water. The effects of smelt-water explosions are described below.^{28, 29} A schematic of the recovery boiler is shown in Figure 10.

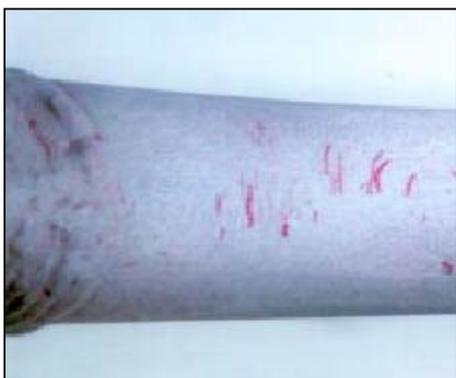
Figure 12a: Circumferential Cracking

If a boiler tube cracks, it can cause an unplanned shutdown and additional damage to the boiler. Photographs of two types of cracking commonly found in recovery boiler floor tubes are shown in Figure 12 (this figure is described in more detail in Appendix A).³⁶ When cracks in the boiler tubes extend deep enough to allow water and steam to leak into the molten smelt environment of the recovery boiler, a large explosion can occur. In a 1998 review of recovery boiler accidents, David Parrish (P.E. of the Factory Mutual Research Corporation) noted that the instantaneous vaporization of one pound of

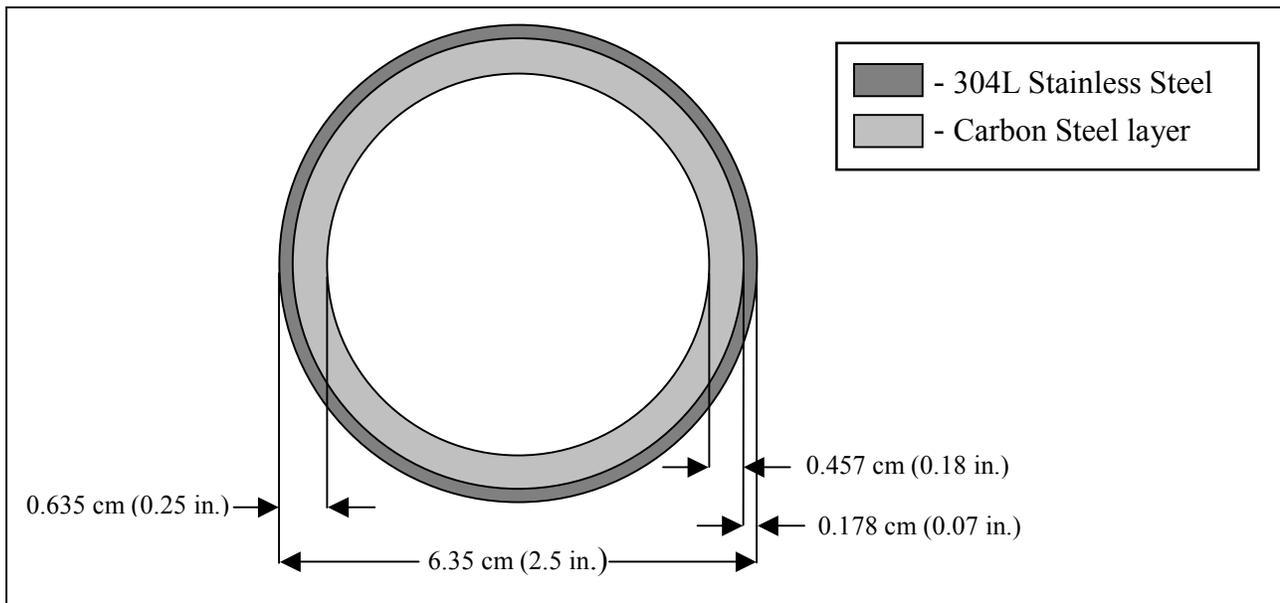
Figure 14: Schematic of Composite Tube Cross-Section⁴²

Type 304L stainless steel was chosen for the outer surface of the composite tubes because of its resistance to sulfidation at high temperatures. Tubes are typically fabricated with a total wall thickness of about 0.635 cm (0.25 in.), inner tube wall thickness of about 0.457 cm (0.18 in.), outer tube wall thickness of about 0.178 cm (0.07 in.), and external diameter of 6.35 to 7.62 cm (2.5 to 3.0 in.). Figure 14 is a schematic of a 6.35 cm (2.5 in.) composite tube cross-section.

⁴² Figure 14 is a scale drawing of a 6.35 cm (2.5 in.) composite tube cross-section.

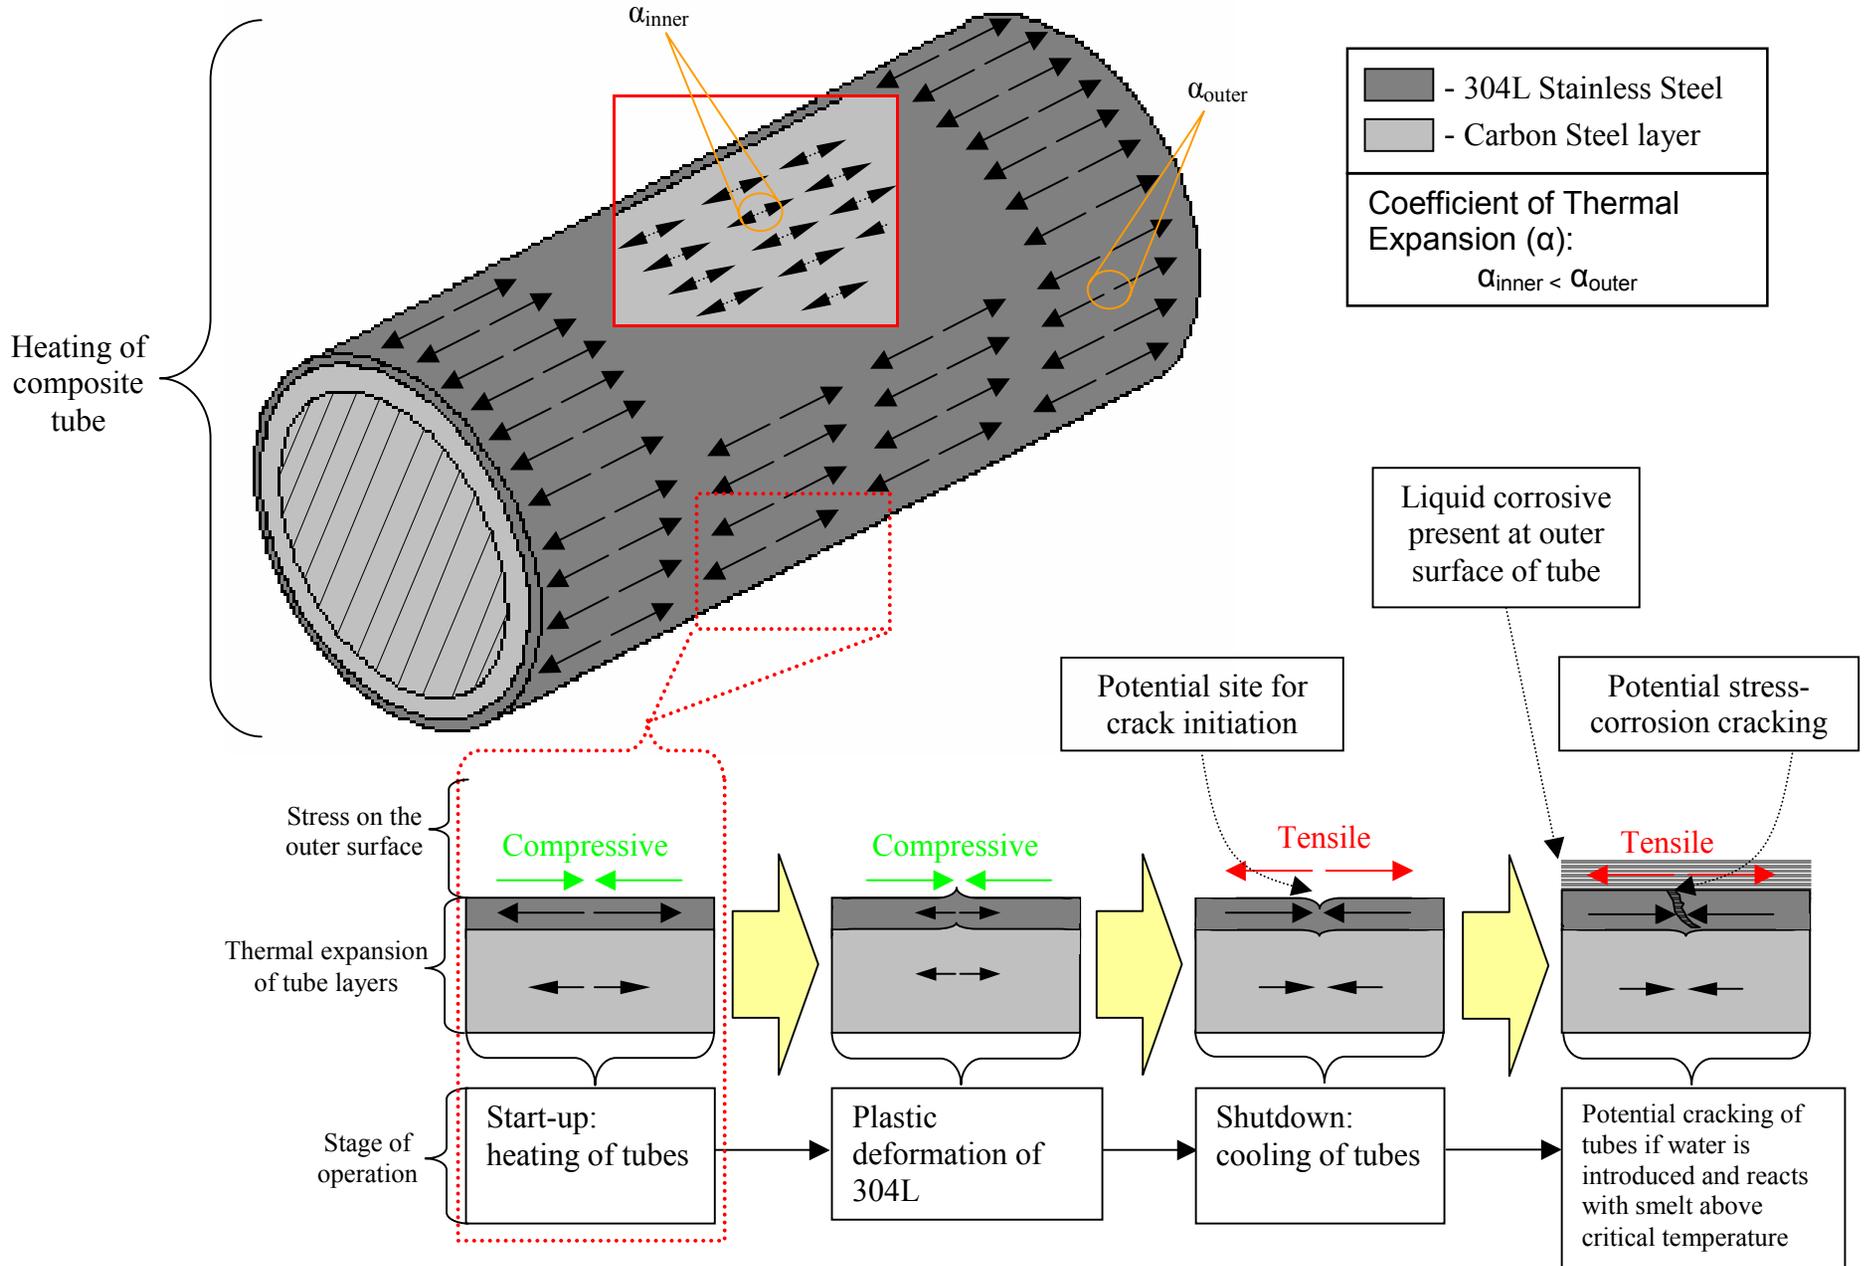
Figure 16: Schematic of Stress-Corrosion Cracking on Composite Floor Tubes in Recovery Boilers

It is important to remember that, under normal operating conditions, tensile stresses are only formed on the 304L stainless steel and not on Incoloy 825 or Inconel 625. Both the Incoloy 825 or Inconel 625 have a higher yield strength than the 304L stainless steel and a rate of thermal expansion closer to that of the inner layer of carbon steel. However, at least one condition is known to change the stresses present at the surface of the Incoloy 825 or Inconel 625 to tensile. This condition is the occurrence of a thermal fluctuation. A thermal fluctuation may be caused when a fracture occurs in the solid layer of smelt at the boiler floor. This can allow molten smelt to flow down nearer to the boiler floor tubes, creating a rapid increase and decrease in the temperature of the tube. If the temperature fluctuation is large enough, it can cause both Incoloy 825 and Inconel 625 to plastically deform by the same mechanism described above as in the case of the 304L stainless steel under normal operating conditions. If the thermal fluctuation is large enough to apply stresses that exceed the yield strength, the material will plastically deform. In addition, thermal fluctuations can make the tensile stresses already present in the 304L stainless steel even more severe, leading to a higher likelihood of cracking.

It is estimated that tubes manufactured with 304L stainless steel will plastically deform with a thermal fluctuation of approximately 50°C or greater; Incoloy 825 will plastically deform with a thermal fluctuation of approximately 100°C or greater; and Inconel 625 will plastically deform with a thermal fluctuation of 150°C or greater. The Inconel 625 requires the largest thermal fluctuation to plastically deform because it has the highest yield strength and the closest match to the rate of expansion of the carbon steel layer. Likewise, the Incoloy 825 requires the second-largest thermal fluctuation to plastically deform, because it has the second-highest yield strength and the second-best match to the rate of expansion of the carbon steel layer. Higher temperature fluctuations occur less frequently (see Table A1 in Appendix A). *While no material is immune to the problem of thermal fluctuations, materials with a closer match to the thermal expansion rate of carbon steel and higher yield strengths are more resistant. Thermal fluctuations can cause tensile stresses in all materials tested if they are of sufficient magnitude and the rate of expansion is not sufficiently close enough to that of the carbon steel layer. These stresses can promote stress-corrosion cracking in the localized area of the thermal fluctuation.*

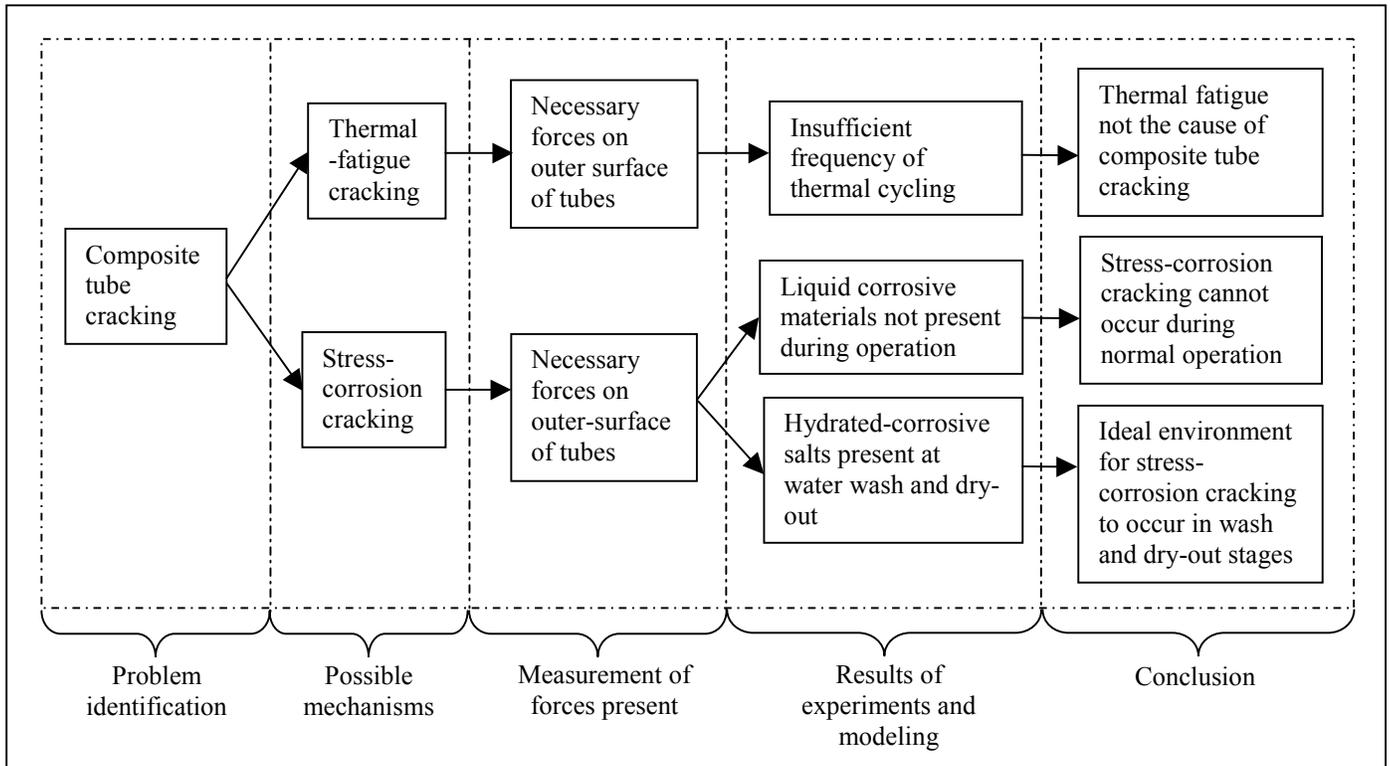
Figure 17: Determination of Cracking Mechanism

Returning to our earlier analogy of a stretched rubber band that has a small piece of rubber cut out of it, we notice that there are three physical characteristics (materials properties) that are inextricably linked together: (1) the amount that the rubber band is stretched, (2) the strength of the rubber band, and (3) the severity of the piece cut out of the rubber band. Similarly, the boiler floor tubes possess three physical characteristics that are linked together: (1) the differences in expansion and contraction rates between the inner and outer layers (coefficient of thermal expansion), (2) the yield strength, and (3) the resistance to corrosion. The first characteristic determines the magnitude of the force applied on the surface of the tube when the boiler is heated and cooled. The second characteristic determines how well the material will be able to resist the forces applied from the first characteristic (i.e. whether a tensile stress will result). The third characteristic determines how effectively a corrosive substance can attack the material. Notice that no single undesirable characteristic can cause stress-corrosion cracking. This set of intimately connected physical characteristics is referred to as a suite of materials properties. Figure 18 a, b, and c show a schematic of the materials properties suites for the materials examined in this study.

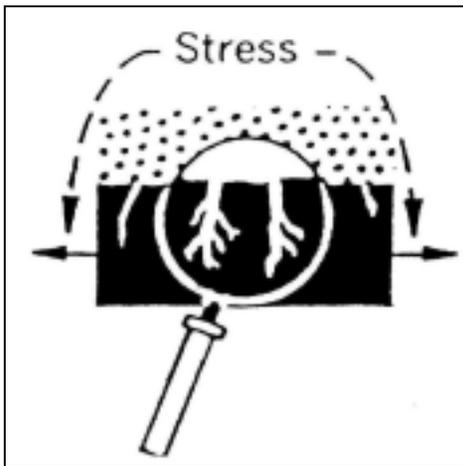
Figure A2a: Representative Sketch of Stress-Corrosion Cracking

The results of these studies defined the general characteristics of composite tube cracking.⁶⁸ These general characteristics suggested two potential cracking mechanisms. The first possibility is thermal fatigue. Thermal-fatigue cracking requires thermal variations that create stresses that exceed the yield strength of the composite tube. The second possibility is stress-corrosion cracking. This requires both a tensile stress and a liquid corrosive material to be present in the critical temperature range. Both of these mechanisms require tensile stresses to be present at the outer layer of the composite tube, which suggested the importance of residual stress measurements.⁶⁹

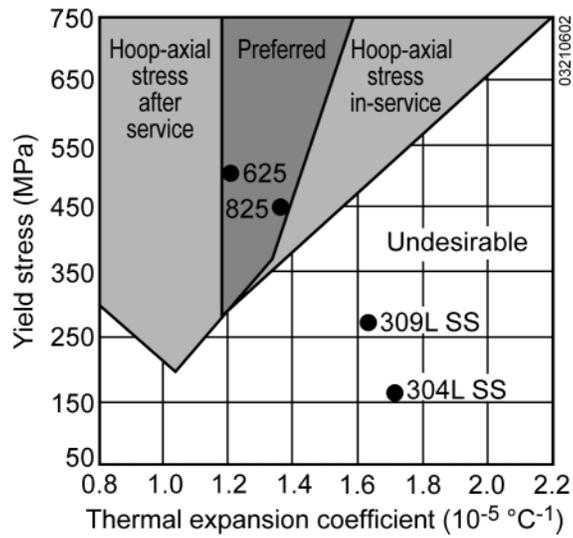
Figure A5: Yield Stress versus Thermal Expansion Coefficient for Selected Materials⁸²

Stresses generated in coextruded tube materials at various thermal expansion coefficients and yield stresses for the outer clad layer. Alloys 625 and 825 have properties that result in less severe stresses being developed than with 304L or 309L.
